**Sacramento Regional Transit
District**

Stockton Boulevard Implementation Plan

July 2023

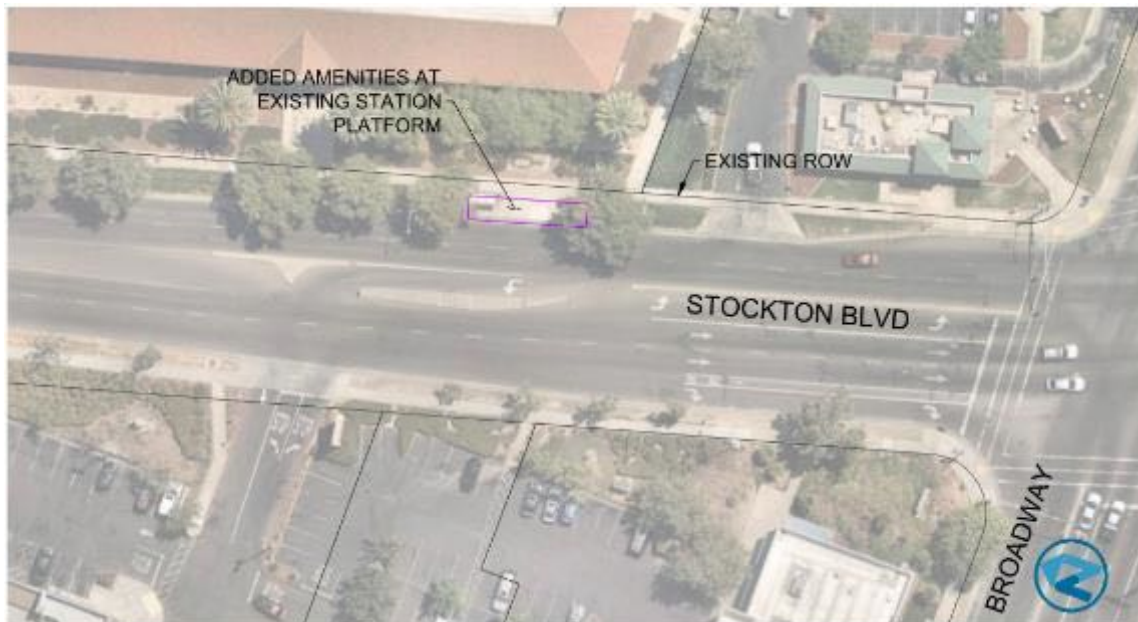
Figure 19 Stockton Blvd & Broadway NB Tier 1 Improvements

Broadway northbound (NB) and southbound (SB) (stop IDs 1807 and 1839, respectively) have high daily ridership of 68 and 132 daily riders, respectively. Both existing bus stops are on the far-side of Broadway with concrete landing areas and have a shelter with bench and trash receptacle. The NB stop has existing RTIS in place, and the SB stop has existing plans of RTIS being installed, per coordination with SacRT. Both stops are fully ADA compliant.

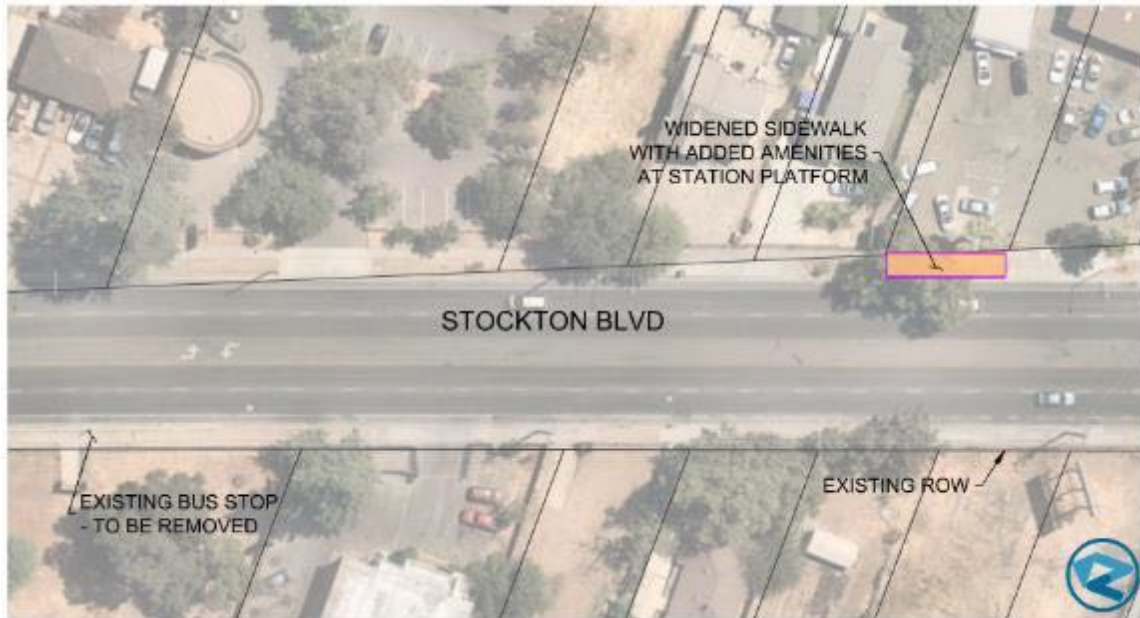
Figure 23 20th Ave NB Tier 1 Improvements

Parker Ave and Roosevelt Ave both have SB transit stops (stop IDs 1846 and 1847, respectively) with low daily ridership counts of 20 daily riders for Parker Ave and 11 daily riders for Roosevelt Ave. These two stops are located 430' apart from each other on the same block with no existing amenities at either location. The nearest SB stop to the north of Parker

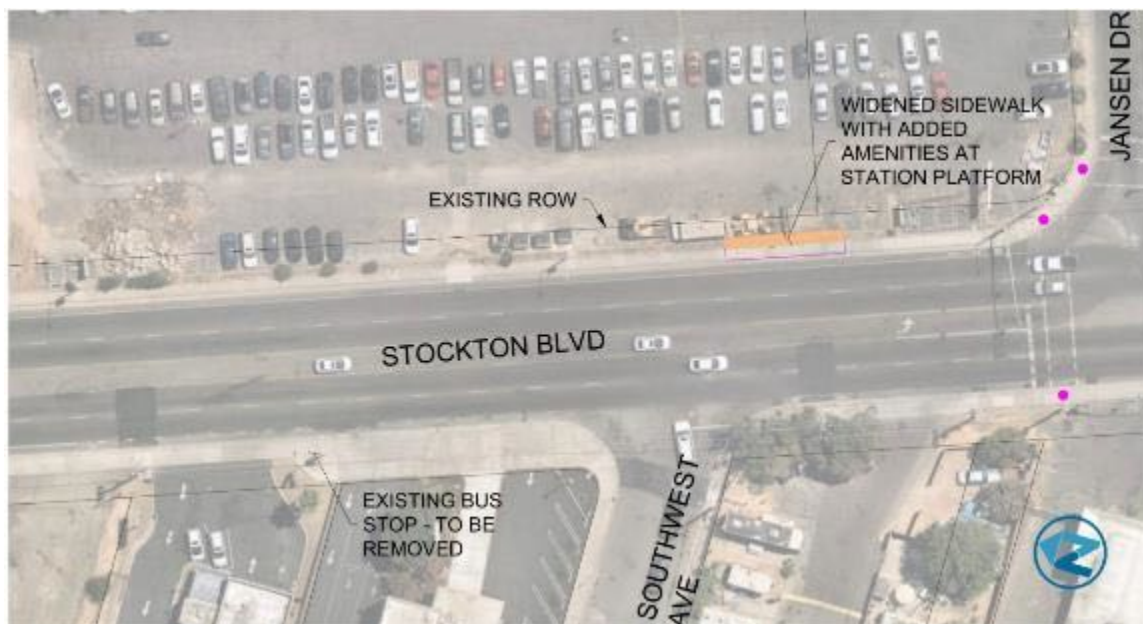
Figure 31 Southwest Ave SB/Jansen Dr NB Tier 1 Improvements

Southwest Ave and Gordon Drive currently both have SB transit stops (1852 and 1853, respectively) with relatively low daily ridership counts of 17 and 15 passengers per day, respectively. These two stops are 850' apart from each other and both are located between two driveways with minimal space for additional amenities. The Southwest Ave bus stop is located 840' from the Fruitridge Rd stop to the north and Gordon Dr bus stop is located 730' from the McMahon Drive stop to the south. Neither stop currently has a NB station pair, however there is a singular NB bus stop at the far side of Jansen Drive.

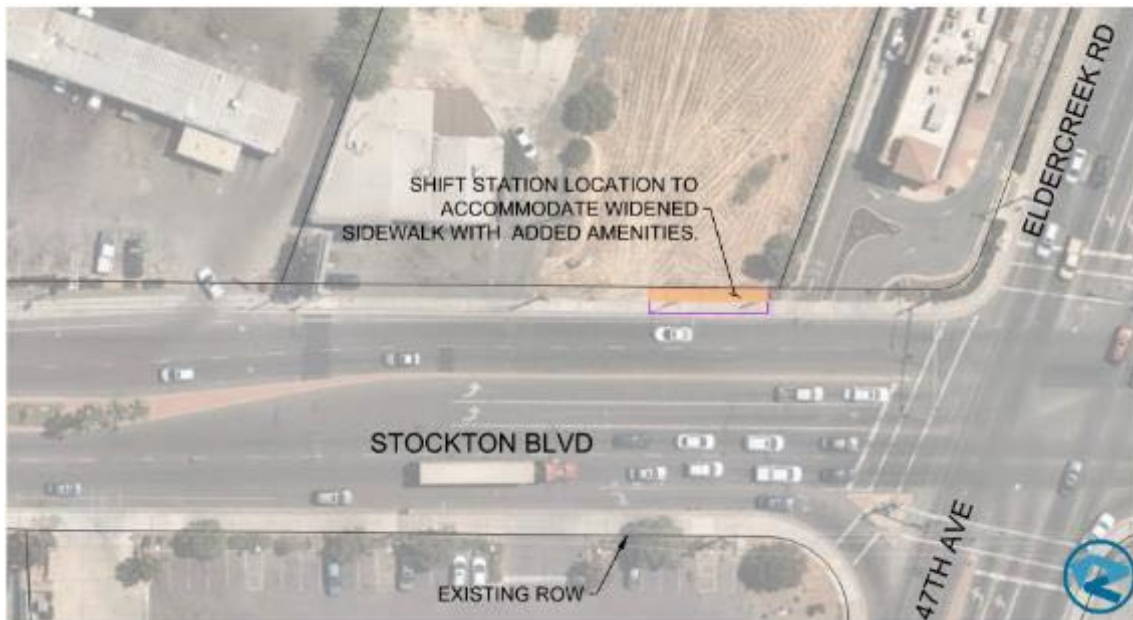
Figure 39 Eldercreek Rd NB Tier 1 Improvements

Eldercreek Rd NB and 47th Ave SB (NB 1887, SB 1857) have an existing high ridership of 58 daily riders for the NB direction and 65 daily riders for the SB direction. The NB stop is a far-side near a drive-thru exit with a 5' sidewalk and no existing landing area and no amenities. The SB stop is a far-side stop at an open lot with a sign and no amenities. The landing area

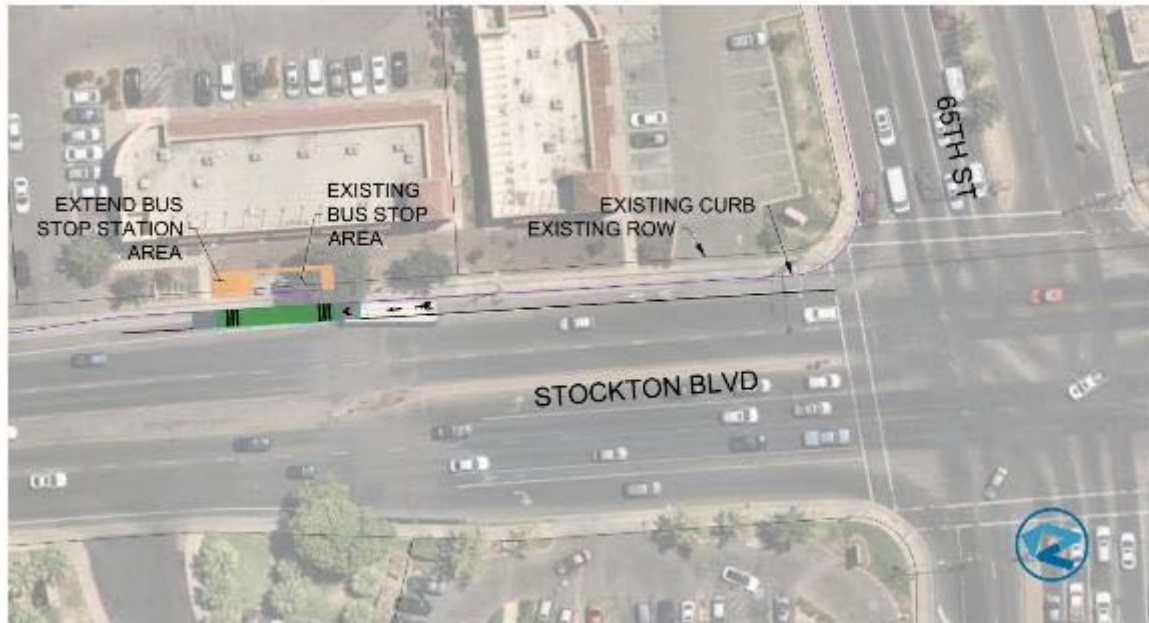
Figure 43 65th St Tier 1 NB Improvements

The 65th Street bus stops (NB 1884, SB 1860) have the highest ridership on the Stockton Blvd corridor with 252 daily riders for the NB direction and 407 daily riders for the SB direction. These stops are located in a mix of shopping plazas and have potential east-west transfer points on 65th Street. Both stops are currently located at bus pull-outs on the far-side of 65th Street with a shelter with a bench and trash receptacle at the NB stop and a bench and trash receptacle at the SB stop. The SB bus stop does not currently have an accessible landing area.

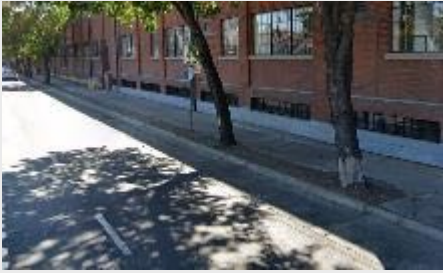
Figure A- 1 Stockton Blvd & Alhambra Blvd

Alhambra Blvd Southbound	
Stop ID	1792	
Daily Ridership	Boarding: 0 Alighting: 0	
Cost	Tier 1: \$126,825 Tier 2: N/A	
Key Considerations (ADA, ROW)	<ul style="list-style-type: none"> ▪ No Landing Area ▪ Tier 1 and Tier 2: 0' ROW Required 	
Proposed Improvements	<p>Tier 1: Widen sidewalk up to curb at bus flag for adequate landing area. Add Braille signage, bench, and route map.</p> <p>Tier 2: No additional Tier 2 improvements due to low ridership.</p>	
Image Credit: Google Maps

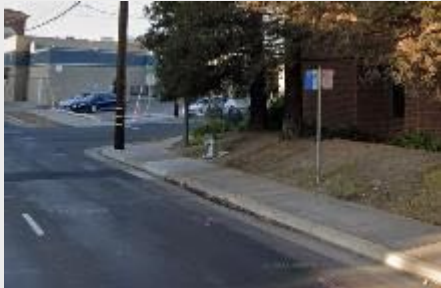
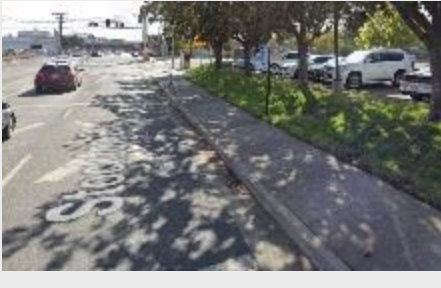
Figure A- 2 Stockton Blvd & 34th St

34 th St Eastbound	34 th St Westbound
Stop ID	1793	1824
Daily Ridership	Boarding: <1 Alighting: <1 Total: 1	Boarding: <1 Alighting: <1 Total: <1
Cost	Tier 1: \$127,000 Tier 2: N/A	Tier 1: \$127,000 Tier 2: N/A
Key Considerations (ADA, ROW)	<ul style="list-style-type: none"> ▪ No Landing Area ▪ Tier 1 and Tier 2: 0' ROW Required 	<ul style="list-style-type: none"> ▪ No Landing Area ▪ Tier 1 and Tier 2: 0' ROW Required
Proposed Improvements	<p>Tier 1: Widen station area at back of sidewalk for accessible landing area, Braille signage, route map, and bench.</p> <p>Tier 2: No additional Tier 2 improvements due to low ridership.</p>	<p>Tier 1: Widen station area at back of sidewalk for accessible landing area, Braille signage, route map, and bench.</p> <p>Tier 2: No additional Tier 2 improvements due to low ridership.</p>
Image Credit: Google Maps

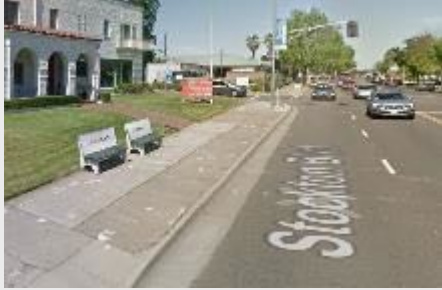
Figure A- 3 Stockton Blvd & Miller Way SB

Miller Way Southbound	
Stop ID	3717	
Daily Ridership	Boarding: 2 Alighting: 3 Total: 5	
Cost	Tier 1: \$300 Tier 2: \$300	
Key Considerations (ADA, ROW)	<ul style="list-style-type: none"> ▪ Landing Area and Curb Ramp Accessible ▪ Low ridership and no station pair ▪ Tier 1 and Tier 2: 0' ROW Required 	
Proposed Improvements	<p>Tier 1: Add Braille signage, and system and route maps.</p> <p>Tier 2: Add striped crosswalk on south leg of intersection, Braille signage, and system and route maps.</p>	
Image Credit: Google Maps

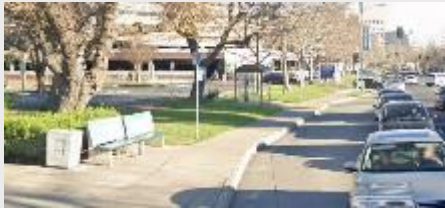
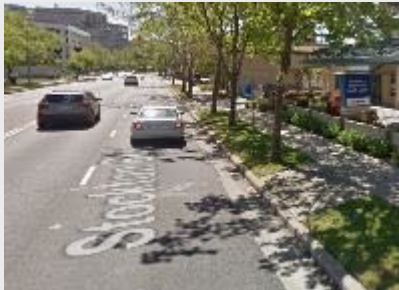
Figure A- 4 Stockton Blvd & Colonial Way

Colonial Way Northbound	Colonial Way Southbound
Stop ID	1811	3718
Daily Ridership	Boarding: 5 Alighting: 2 Total: 7	Boarding: 1 Alighting: 3 Total: 4
Cost	Tier 1: \$155,800 Tier 2: \$470,000	Tier 1: \$164,300 Tier 2: \$164,300
Key Considerations (ADA, ROW)	<ul style="list-style-type: none"> ▪ Landing Area and Curb Ramp Accessible ▪ Tier 1: 5' ROW Required ▪ Tier 2: 0' ROW Required 	<ul style="list-style-type: none"> ▪ Landing Area and Curb Ramp Accessible ▪ Tier 1 and Tier 2: 0' ROW Required
Proposed Improvements	<p>Tier 1: Widen station platform to the south at the back of sidewalk accommodate shelter with bench, Braille signage, and route map.</p> <p>Tier 2: Fill in pullout to create in-lane stop. Create station platform with shelter with bench, Braille signage, and route map. Add pedestrian crossing on north leg of intersection and 2 new curb ramps.</p>	<p>Tier 1: Extend station platform between curb and sidewalk to the south to accommodate shelter with bench, Braille signage, and route map.</p> <p>Tier 2: Maintain Tier 1 improvements. Shift stop bar on west leg of intersection back and add crosswalk striping</p>

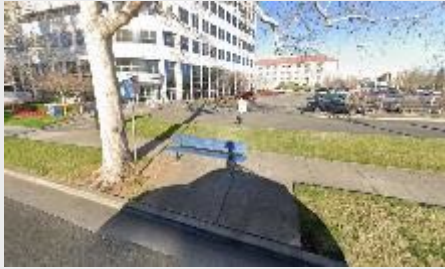
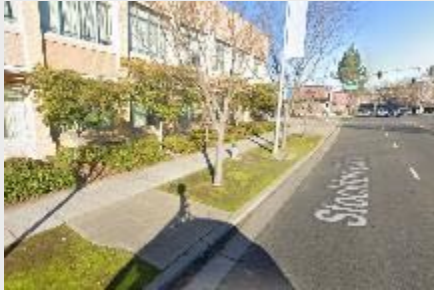
Figure A- 6 Stockton Blvd & 2nd Ave

2 nd Ave Northbound	2 nd Ave Southbound
Stop ID	1809	3720
Daily Ridership	Boarding: 8 Alighting: 2 Total: 10	Boarding: 3 Alighting: 2 Total: 5
Cost	Tier 1: \$2,300 Tier 2: N/A	Tier 1: \$300 Tier 2: N/A
Key Considerations (ADA, ROW)	<ul style="list-style-type: none"> Existing landing area potentially blocked by bench. Cost assumed for maintenance crew to remove amenities. Tier 1 and Tier 2: 0' ROW Required 	<ul style="list-style-type: none"> No Landing Area Tier 1 and Tier 2: 0' ROW Required
Proposed Improvements	<p>Tier 1: Propose remove stop. Remove bench and flag.</p> <p>Tier 2: No additional improvements due to removed stop.</p>	<p>Tier 1: Propose remove stop.</p> <p>Tier 2: No additional improvements due to removed stop.</p>
Image Credit: Google Maps

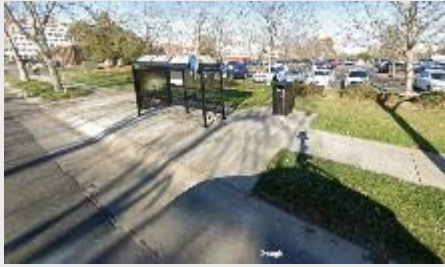
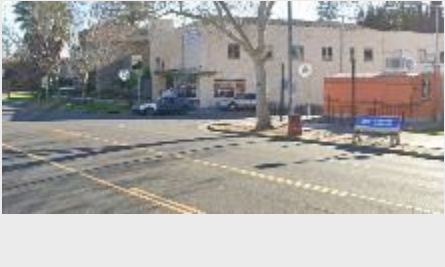
Figure A- 7 Stockton Blvd & 3rd Ave

3 rd Ave Northbound	3 rd Ave Southbound
Stop ID	1808	3721
Daily Ridership	Boarding: 3 Alighting: 2 Total: 5	Boarding: 2 Alighting: 3 Total: 5
Cost	Tier 1: \$4,800 Tier 2: \$1,115,700	Tier 1: \$166,000 Tier 2: \$181,000
Key Considerations (ADA, ROW)	<ul style="list-style-type: none"> ▪ Landing Area and Curb Ramp Accessible ▪ Tier 1 and Tier 2: 0' ROW Required 	<ul style="list-style-type: none"> ▪ No landing area ▪ Tier 1 and Tier 2: 0' ROW Required
Proposed Improvements	<p>Tier 1: Relocate shelter to back of sidewalk and add Braille signage.</p> <p>Tier 2: Relocate stop and amenities closer to far-side 3rd Ave. Add Braille signage, pedestrian crossing with a pedestrian signal, 3 new curb ramps.</p>	<p>Tier 1: Create a formal station area by widening sidewalk up to curb to accommodate accessible landing area, shelter with bench, Braille signage and route map.</p> <p>Tier 2: Maintain Tier 1 improvements. Upgrade curb ramp on the south corner of 3rd and Stockton Blvd.</p>

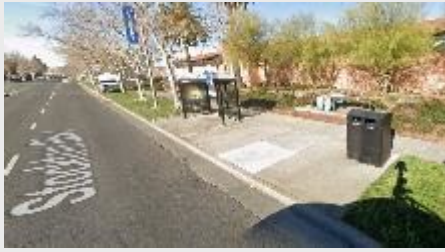
Figure A- 8 Stockton Blvd & Broadway

Broadway Northbound	Broadway Southbound
Stop ID	1807	1839
Daily Ridership	Boarding: 20 Alighting: 47 Total: 68	Boarding: 78 Alighting: 54 Total: 132
Cost	Tier 1: \$83,700 Tier 2: \$83,700	Tier 1: \$83,700 Tier 2: \$170,900
Key Considerations (ADA, ROW)	<ul style="list-style-type: none"> ▪ Landing Area and Curb Ramp Accessible ▪ Tier 1 and Tier 2: 0' ROW Required 	<ul style="list-style-type: none"> ▪ Landing Area and Curb Ramp Accessible ▪ Tier 1 and Tier 2: 0' ROW Required
Proposed Improvements	<p>Tier 1: Maintain existing conditions, add Braille signage and pedestrian scale lighting.</p> <p>Tier 2: No additional Tier 2 Improvements.</p>	<p>Tier 1: Maintain existing conditions, add Braille signage and pedestrian scale lighting.</p> <p>Tier 2: Create shared cycle track stop, add Braille signage and pedestrian scale lighting.</p>
Image Credit: Google Maps

Due to the roadway narrowing at the NB bus stop location, pedestrian and bike improvements would require adjustments along the whole block. As a result, there are no additional recommended Tier 2 improvements. The proposed Tier 2 improvements for the SB stop include creating a shared cycle track stop and adding RTIS, pedestrian scale lighting, and Braille signage.

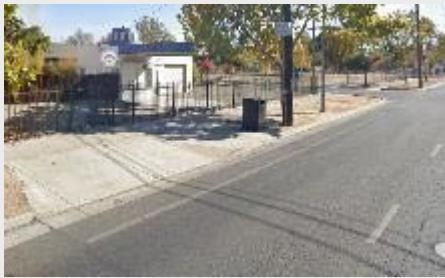
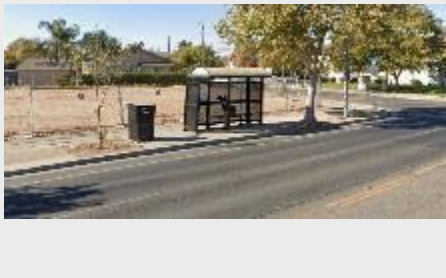
Figure A- 9 Stockton Blvd & 9th Ave

9 th Ave Northbound	9 th Ave Southbound
Stop ID	1902	1841
Daily Ridership	Boarding: 13 Alighting: 10 Total: 23	Boarding: 19 Alighting: 14 Total: 33
Cost	Tier 1: \$223,800 Tier 2: \$458,000	Tier 1: \$300 Tier 2: \$200,200
Key Considerations (ADA, ROW)	<ul style="list-style-type: none"> ▪ Landing Area and Curb Ramp Accessible ▪ Tier 1 and Tier 2: 6' ROW Required 	<ul style="list-style-type: none"> ▪ Landing Area and Curb Ramp Accessible ▪ Tier 1 and Tier 2: 0' ROW Required
Proposed Improvements	<p>Tier 1: Extend station platform to the south to accommodate shelter with bench, Braille signage, and route map. Station area can be improved while maintaining existing tree.</p> <p>Tier 2: Relocate stop to far-side of existing pedestrian signal. Create shared cycle track stop and widen sidewalk to accommodate a formal station area. Maintain all proposed Tier 1 amenities and add a pedestrian refuge at the existing pedestrian crossing.</p>	<p>Tier 1: Add Braille signage.</p> <p>Tier 2: Relocate stop to far- side of existing pedestrian signal. Create shared cycle track stop and widen sidewalk for formal station area. Relocate shelter with bench and trash receptacle. Add Braille signage.</p>

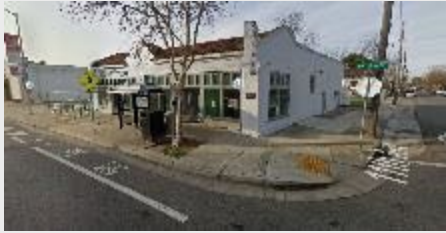
Figure A- 10 Stockton Blvd & 11th Ave

11 th Ave Northbound	11 th Ave Southbound
Stop ID	1901	1842
Daily Ridership	Boarding: 11 Alighting: 5 Total: 16	Boarding: 6 Alighting: 8 Total: 14
Cost	Tier 1: \$234,300 Tier 2: \$1,188,300	Tier 1: \$300 Tier 2: \$226,400
Key Considerations (ADA, ROW)	<ul style="list-style-type: none"> ▪ No landing area ▪ Tier 1 and 2: 1' ROW Required 	<ul style="list-style-type: none"> ▪ Landing Area and Curb Ramp Accessible ▪ Tier 1: 0' ROW Required ▪ Tier 2: 6' ROW Required
Proposed Improvements	<p>Tier 1: Create a formal station area by widening sidewalk up to curb to accommodate accessible landing area, shelter with bench, Braille signage, and route map.</p> <p>Tier 2: Maintain Tier 1 improvements. Upgrade crossing with pedestrian refuge and a pedestrian signal.</p>	<p>Tier 1: Add Braille signage.</p> <p>Tier 2: Relocate station and amenities to far-side of crosswalk. Close driveway for additional space. Add Braille signage and upgrade crossing with pedestrian refuge and a pedestrian signal.</p>

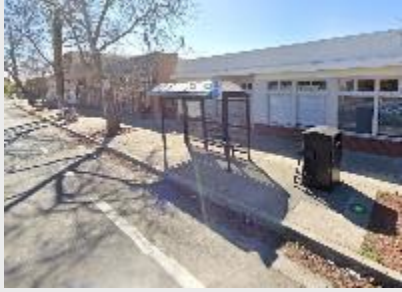
Figure A- 11 Stockton Blvd & 14th Ave

14 th Ave Northbound	14 th Ave Southbound
Stop ID	1899	1843
Daily Ridership	Boarding: 26 Alighting: 11 Total: 37	Boarding: 8 Alighting: 16 Total: 24
Cost	Tier 1: \$300 Tier 2: \$206,000	Tier 1: \$300 Tier 2: \$87,500
Key Considerations (ADA, ROW)	<ul style="list-style-type: none"> ▪ Landing Area and Curb Ramp Accessible ▪ Tier 1 and Tier 2: 0' ROW Required 	<ul style="list-style-type: none"> ▪ Landing Area and Curb Ramp Accessible ▪ Tier 1: 0' ROW Required ▪ Tier 2: 8' ROW Required
Proposed Improvements	<p>Tier 1: Add Braille signage.</p> <p>Tier 2: Close driveway closest to intersection to provide pedestrian crossing on north leg of intersection and add Braille signage.</p>	<p>Tier 1: Add Braille signage.</p> <p>Tier 2: Relocate stop to far-side 14th Ave. Relocate existing shelter and trash receptacle to new location. Add Braille signage.</p>
Image Credit: Google Maps

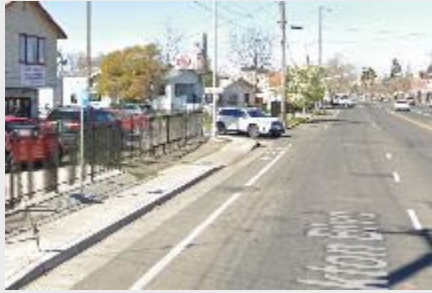
Figure A- 12 Stockton Blvd & 15th Ave

15 th Ave Southbound
Stop ID		1844
Daily Ridership		Boarding: 5 Alighting: 11 Total: 16
Cost		Tier 1: \$300 Tier 2: \$0
Key Considerations (ADA, ROW)		<ul style="list-style-type: none"> ▪ No landing area ▪ Tier 1 and Tier 2: 0' ROW Required
Proposed Improvements		Tier 1: Remove bus stop. Tier 2: Consolidate 14 th Ave SB and 15 th Ave SB stops by relocating these stops to one stop on far-side of 14 th Ave.
Image Credit: Google Maps

- 15th Ave SB (stop ID 1844) is an existing far-side bus stop with no amenities, no station pair, and no accessible landing area. This bus stop is location 575' south of the 14th Ave bus stop and 640' north of the 17th Ave bus stop. Due to the low daily ridership of this bus stop at 14 people per day, and the proximity to both the 14th Ave and 17th Ave bus stops, it is recommended that this bus stop be removed and consolidated with the 14th Ave bus stop.

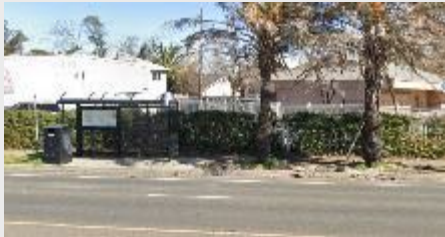
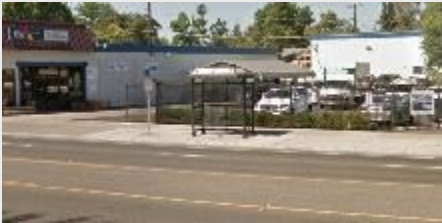
Figure A- 13 Stockton Blvd & San Francisco Blvd NB/17th Ave SB

San Francisco Blvd Northbound	17 th Ave Southbound
Stop ID	1898	1845
Daily Ridership	Boarding: 30 Alighting: 11 Total: 41	Boarding: 10 Alighting: 21 Total: 31
Cost	Tier 1: \$300 Tier 2: \$1,424,700	Tier 1: \$300 Tier 2: \$171,500
Key Considerations (ADA, ROW)	<ul style="list-style-type: none"> ▪ Landing Area and Curb Ramp Accessible ▪ Tier 1 and Tier 2: 0' ROW Required 	<ul style="list-style-type: none"> ▪ Landing Area and Curb Ramp Accessible ▪ Tier 1: 0' ROW Required ▪ Tier 2: 13' ROW Required
Proposed Improvements	<p>Tier 1: Add Braille signage.</p> <p>Tier 2: Remove midblock signal and add full signal with pedestrian crossings at 17th Ave and Stockton Blvd intersection. Add Braille signage.</p>	<p>Tier 1: Add Braille signage, system and route map.</p> <p>Tier 2: Add Braille signage, system and route map. Remove midblock signal and add full signal with pedestrian crossings at 17th Ave and Stockton Blvd intersection.</p>

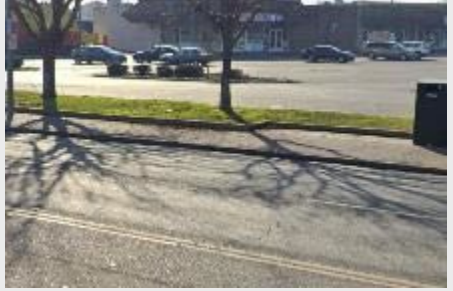
Figure A- 14 Stockton Blvd & Parker Ave SB

Northbound	Parker Ave Southbound
Stop ID		1846
Daily Ridership		Boarding: 11 Alighting: 10 Total: 21
Cost		Tier 1: \$300 Tier 2: \$300
Key Considerations (ADA, ROW)		<ul style="list-style-type: none"> ▪ No landing area ▪ Tier 1 and Tier 2: 0' ROW Required
Proposed Improvements		Tier 1: Remove bus stop. Tier 2: Remove bus stop.
Image Credit: Google Maps

To allow for better stop access and more reliable service, it is recommended to consolidate the Parker Ave and Roosevelt Ave bus stops into one bus stop at the far side of Roosevelt Ave. The resulting SB stop is spaced 1370' south of the 17th Ave stop and 800' north of the 21st Ave stop. Additional Tier 1 improvements for the new Roosevelt Ave SB Stop and station pair at 20th Ave NB locations include widening the sidewalk to accommodate an accessible landing area, a shelter with a bench, Braille signage, and system and route maps.

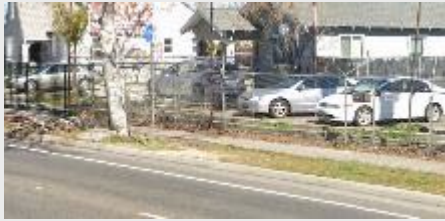
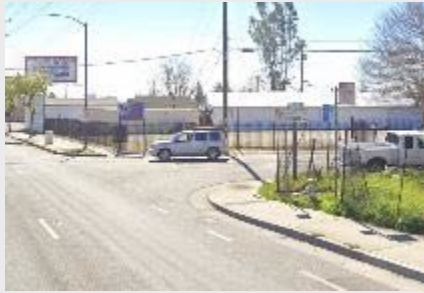
Figure A- 15 Stockton Blvd & 20th Ave NB/ Roosevelt Ave SB

20 th Ave Northbound	Roosevelt Ave Southbound
Stop ID	1896	1847
Daily Ridership	Boarding: 10 Alighting: 11 Total: 21	Boarding: 4 Alighting: 7 Total: 11
Cost	Tier 1: \$208,800 Tier 2: \$1,179,800	Tier 1: \$99,500 Tier 2: \$209,200
Key Considerations (ADA, ROW)	<ul style="list-style-type: none"> ▪ No landing area ▪ Tier 1 and Tier 2: 0' ROW Required 	<ul style="list-style-type: none"> ▪ No landing area ▪ Tier 1 and Tier 2: 10' ROW required
Proposed Improvements	<p>Tier 1: Create a formal station area by widening sidewalk up to curb to accommodate accessible landing area, shelter with bench, Braille signage, and route map.</p> <p>Tier 2: Maintain Tier 1 improvements. Create cycle track stop, midblock crossing, including pedestrian refuge and a pedestrian signal.</p>	<p>Tier 1: Relocate stop to far-side of Roosevelt Ave. Add shelter with bench, Braille signage, and route map.</p> <p>Tier 2: Tier 1 with cycle track stop, midblock crossing, including two new curb ramps, pedestrian refuge, and a pedestrian signal.</p>

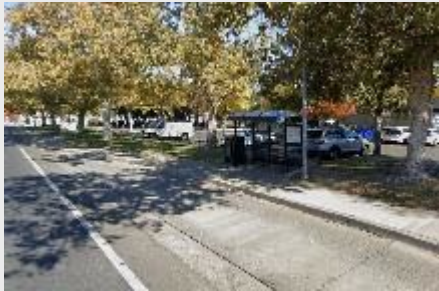
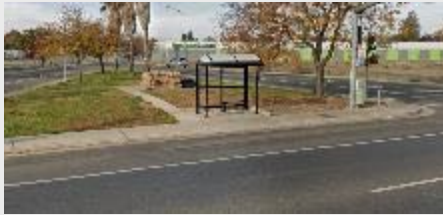
Figure A- 16 Stockton Blvd & 21st Ave

21 st Ave Northbound	21 st Ave Southbound
Stop ID	1895	1848
Daily Ridership	Boarding: 34 Alighting: 18 Total: 54	Boarding: 15 Alighting: 27 Total: 42
Cost	Tier 1: \$100,200 Tier 2: \$389,900	Tier 1: \$300 Tier 2: \$224,700
Key Considerations (ADA, ROW)	<ul style="list-style-type: none"> ▪ Landing Area and Curb Ramp Accessible ▪ Tier 1: 13.5' ROW Required ▪ Tier 2: 6' ROW Required 	<ul style="list-style-type: none"> ▪ Landing Area and Curb Ramp Accessible ▪ Tier 1 and Tier 2: 0' ROW Required
Proposed Improvements	<p>Tier 1: Add RTIS, Braille signage, and pedestrian scale lighting.</p> <p>Tier 2: Create transit island, routing bike lane behind bus stop. Relocate existing amenities and add pedestrian scale lighting.</p>	<p>Tier 1: Add Braille signage, system and route maps.</p> <p>Tier 2: Create dedicated bike lane with shared cycle track stop. Add Braille signage, system and route maps.</p>
Image Credit: Google Maps

- 21st Ave NB and SB (stop IDs 1895 and 1848, respectively) are both far-side stops with shelter and benches and are fully ADA compliant. The daily ridership for the NB bus stop is 52 passengers, and the daily ridership for the SB bus stop is 42 passengers. Improvements to bring this station pair up to the standards identified in this report are to add RTIS, Braille signage, and pedestrian scale lighting at both locations, and add system and route maps that are currently missing from the SB bus stop. While the SB bus stop is under the threshold for RTIS and pedestrian scale lighting, these amenities are recommended with the anticipation that improving the bus stop will create a better station environment and bring additional passengers.

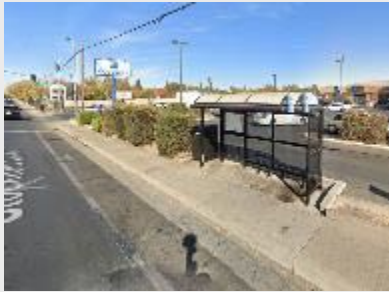
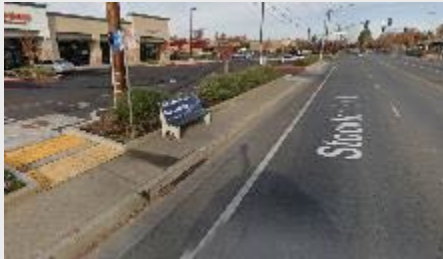
Figure A- 17 Stockton Blvd & Lawrence Dr

Lawrence Dr Northbound	Lawrence Dr Southbound
Stop ID	1894	1849
Daily Ridership	Boarding: 38 Alighting: 12 Total: 50	Boarding: 13 Alighting: 30 Total: 43
Cost	Tier 1: \$143,800 Tier 2: \$232,400	Tier 1: \$158,600 Tier 2: \$228,500
Key Considerations (ADA, ROW)	<ul style="list-style-type: none"> ▪ No Landing Area ▪ Tier 1: 0' ROW Required ▪ Tier 2: 3' ROW Required 	<ul style="list-style-type: none"> ▪ No Landing Area ▪ Tier 1 and Tier 2: 0' ROW Required
Proposed Improvements	<p>Tier 1: Add RTIS, pedestrian scale lighting and Braille signage.</p> <p>Tier 2: Create shared cycle track and widen sidewalk into existing landscaping and parking lot to accommodate more pedestrian waiting space, RTIS, pedestrian scale lighting, and Braille signage.</p>	<p>Tier 1: Widen sidewalk into the existing landscaping to accommodate station platform with accessible landing area, shelter with bench, pedestrian scale lighting, trash receptacle, and Braille signage.</p> <p>Tier 2: Create shared cycle track stop and widen station area along back the of sidewalk to accommodate accessible landing area, shelter with bench, pedestrian scale lighting, trash receptacle, and Braille signage.</p>

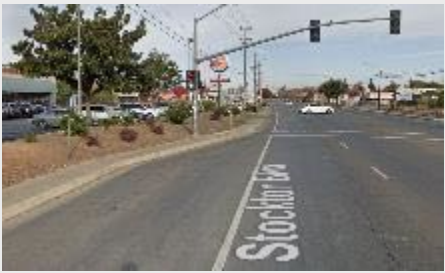
Figure A- 18 Stockton Blvd and Fruitridge Rd (Plaza)

Fruitridge Rd (Plaza) Northbound	Fruitridge Rd (Plaza) Southbound
Stop ID	1893	1850
Daily Ridership	Boarding: 50 Alighting: 14 Total: 64	Boarding: 25 Alighting: 78 Total: 103
Cost	Tier 1: \$170,600 Tier 2: \$272,700	Tier 1: \$164,700 Tier 2: \$798,000
Key Considerations (ADA, ROW)	<ul style="list-style-type: none"> ▪ No Landing Area ▪ Tier 1 and Tier 2: 0' ROW Required 	<ul style="list-style-type: none"> ▪ No Landing Area ▪ Tier 1 and Tier 2: 4' ROW Required
Proposed Improvements	<p>Tier 1: Extend station platform along back of sidewalk to accommodate shelter with bench, RTIS, trash receptacle, system and route maps, Braille signage, and pedestrian scale lighting.</p> <p>Tier 2: Maintain Tier 1 improvements. Create a shared cycle track stop.</p>	<p>Tier 1: Extend station platform along back of sidewalk to accommodate shelter with bench, RTIS, trash receptacle system and route maps, Braille signage, and pedestrian scale lighting.</p> <p>Tier 2: Create a transit island routing bike lane behind bus stop. Add shelter with bench, RTIS, trash receptacle system and route maps, Braille signage, and pedestrian scale lighting. Straighten midblock crossing, add a pedestrian refuge and two new curb ramps.</p>

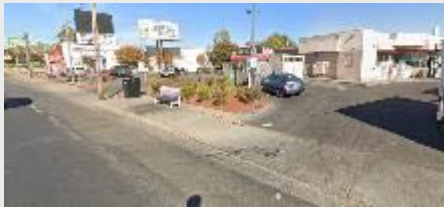
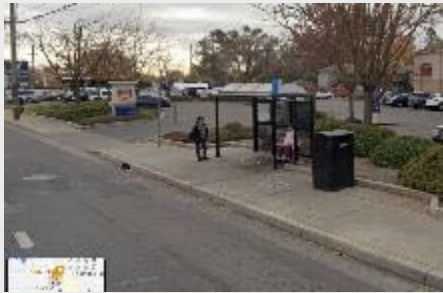
Figure A- 19 Stockton Blvd & Fruitridge Rd

Fruitridge Rd Northbound	Fruitridge Rd Southbound
Stop ID	1892	1851
Daily Ridership	Boarding: 76 Alighting: 42 Total: 118	Boarding: 53 Alighting: 49 Total: 102
Cost	Tier 1: \$199,100 Tier 2: \$397,400	Tier 1: \$216,700 Tier 2: \$216,700
Key Considerations (ADA, ROW)	<ul style="list-style-type: none"> ▪ Landing Area Accessible ▪ Curb ramps require minor upgrades ▪ Tier 1: 7' ROW Required ▪ Tier 2: 3' ROW Required 	<ul style="list-style-type: none"> ▪ Landing Area accessible ▪ Curb ramps require minor upgrades ▪ Tier 1 and Tier 2: 4' ROW Required
Proposed Improvements	<p>Tier 1: Use existing landscaping space for additional amenities without affecting existing driveways. Add shelter with bench, RTIS, System and route map, Braille signage, and pedestrian scale lighting. Will require additional ROW. Widen station area along the back of the sidewalk at north end of bus stop to minimum 4' width around utility pole. Upgrade 2 curb ramps on NE corner of intersection</p> <p>Tier 2: Close driveway north of bus stop. Create shared cycle track stop. Widen station area along the back of the sidewalk towards the north to create a minimum 4' width around utility pole. Add shelter with bench, RTIS, System and route map, Braille signage, and pedestrian scale lighting. Upgrade 2 curb ramps on NE corner of intersection.</p>	<p>Tier 1: Add bench, RTIS, Braille signage, and pedestrian scale lighting. Widen station area along the back of the sidewalk towards the south to accommodate a 4' path around existing utility pole. Upgrade 4 curb ramps on NW and SW corner of intersection.</p> <p>Tier 2: Maintain Tier 1 improvements. Due to existing bus pullout being space for operational/layover space, no additional Tier 2 improvements are proposed.</p>

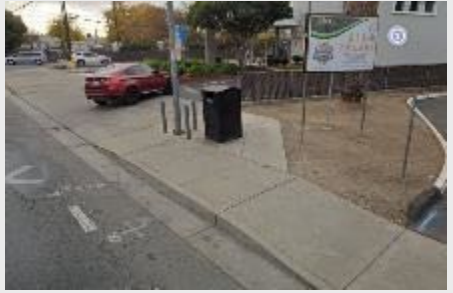
Figure A- 20 Stockton Blvd and Southwest Ave

Southwest Ave SB
Stop ID		1852
Daily Ridership		Boarding: 6 Alighting: 11 Total: 17
Cost		Tier 1: \$300 Tier 2: N/A
Key Considerations (ADA, ROW)		<ul style="list-style-type: none"> ▪ Landing Area and Curb Ramp Accessible ▪ Tier 1 and Tier 2: 0' ROW Required
Proposed Improvements		Tier 1: Remove bus stop. Stop will be consolidated with Gordon Dr stop and located at far-side of Jansen Dr. Tier 2: No Tier 2 project identified
Image Credit: Google Maps

Note: SB Southwest Ave is recommended to be implemented with improvements at Gordon Dr /Jansen Dr as part of the proposed project.

To provide a bus stop with a more comfortable waiting area, improved accessibility, and proximity to a signalized crossing, it is recommended to consolidate the Southwest Ave and Gordon Dr stops to one bus stop on the far side of Jansen Drive, resulting in SB stop spacing of 1,400' to the Fruitridge stop to the north and 980' to the McMahon Drive stop to the south. Additional Tier 1 improvements include adding a shelter with bench, Braille signage and upgrading the existing curb ramp on the NW corner of the Jansen Drive intersection.

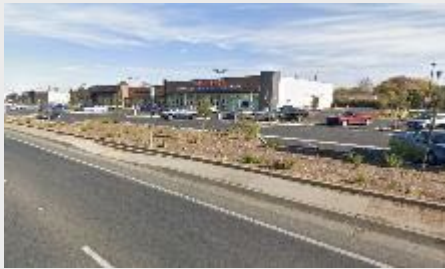
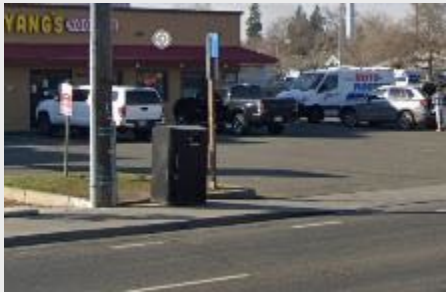
Figure A- 21 Stockton Blvd & Jansen Dr NB/Gordon Dr SB

Jansen Dr NB	Gordon Dr SB
Stop ID	1891	1853
Daily Ridership	Boarding: 17 Alighting: 12 Total: 29	Boarding: 3 Alighting: 12 Total: 15
Cost	Tier 1: \$197,600 Tier 2: \$341,000	Tier 1: \$237,700 Tier 2: \$307,400
Key Considerations (ADA, ROW)	<ul style="list-style-type: none"> No ADA Landing Area Tier 1 and Tier 2: 0' ROW Required 	<ul style="list-style-type: none"> Landing Area and Curb Ramp Accessible Tier 1 and Tier 2: 0' ROW Required
Proposed Improvements	<p>Tier 1: Extend sidewalk into existing landscaping to accommodate shelter with bench, Braille signage, system and route maps. Remove existing curb ramp in middle of sidewalk since it does not lead to a safe crossing and to create a level boarding and alighting area. Upgrade two curb ramps at NE Corner of Jansen Dr.</p> <p>Tier 2: Create shared cycle track stop with station platform behind sidewalk to accommodate shelter with bench, Braille signage, system and route maps. Upgrade two curb ramps at NE Corner of Jansen Dr.</p>	<p>Tier 1: Relocate stop to far-side of Jansen Dr. Close driveway of current empty lot to provide space for station footprint. Assuming consolidated stop will bring higher ridership, add shelter with bench, Braille signage, system and route maps. Upgrade existing curb ramp on north leg of Jansen Dr. intersection.</p> <p>Tier 2: Relocate stop to far-side of Jansen Dr. Close driveway of current empty lot to provide space for station footprint. Assuming consolidated stop will bring higher ridership, add shelter with bench, Braille signage, system and route maps. Upgrade existing curb ramp on north leg of Jansen Dr. intersection. Create shared in-lane stop at new location. Add crossing on south leg of Jansen Dr intersection with 2 new curb ramps and 4 upgraded curb ramps.</p>

The new SB Jansen Dr bus stop will create a station pair to the NB Jansen Dr bus stop. While it is being completed in this area, it is recommended to improve the NB Jansen Drive bus stop as part of the overall improvement project. The NB Jansen Drive bus stop (stop ID 1891) has an existing daily ridership of 29 passengers per day. It is currently a far-side stop with a bench and lacks an ADA compliant landing area.

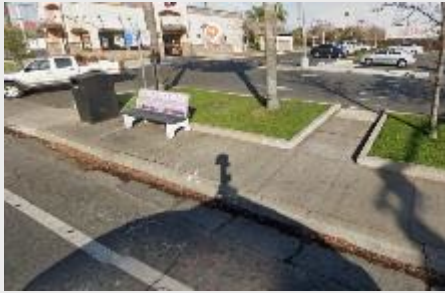
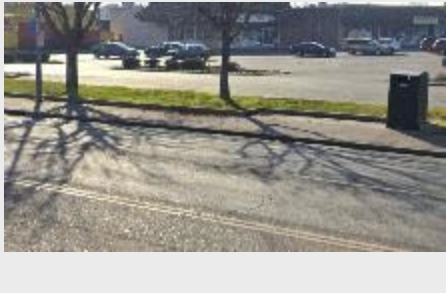
Figure A- 22 Stockton Blvd & McMahon Dr

Northbound	Southbound
Stop ID	1890	1854
Daily Ridership	Boarding: 45 Alighting: 18 Total: 63	Boarding: 21 Alighting: 41 Total: 62
Cost	Tier 1: \$189,700 Tier 2: \$291,900	Tier 1: \$158,200 Tier 2: \$245,300
Key Considerations (ADA, ROW)	<ul style="list-style-type: none"> ▪ No Landing Area ▪ Tier 1 and Tier 2: 0' ROW Required 	<ul style="list-style-type: none"> ▪ Landing Area and Curb Ramp Accessible ▪ Tier 1 and Tier 2: 0' ROW Required
Proposed Improvements	<p>Tier 1: Extend station area along back of sidewalk to accommodate shelter with bench, RTIS, system and route map, Braille signage, and pedestrian scale lighting. Upgrade 3 curb ramps at NE and SE corner of McMahon.</p> <p>Tier 2: Create shared cycle track stop and maintain all Tier 1 improvements.</p>	<p>Tier 1: Extend station area along back of sidewalk to accommodate shelter with bench, RTIS, system and route map, Braille signage, and pedestrian scale lighting.</p> <p>Tier 2: Create shared cycle track stop and maintain all Tier 1 improvements.</p>

The McMahon Dr bus stops (NB 1890, SB 1854) are located near restaurants and shopping plazas with a relatively high daily ridership of 63 and 62 daily passengers for NB and SB, respectively. Existing amenities include a trash receptacle and a bench at the NB station and a trash receptacle at the SB station. The NB stop lacks an ADA compliant landing area and several curb ramps at the intersection require upgrades or replacement, including two on the northeast corner and one on the southeast corner.

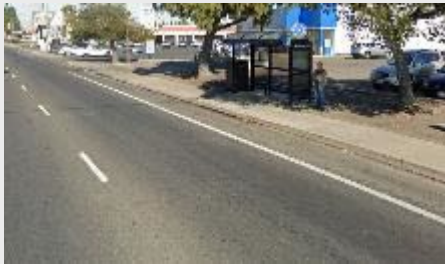
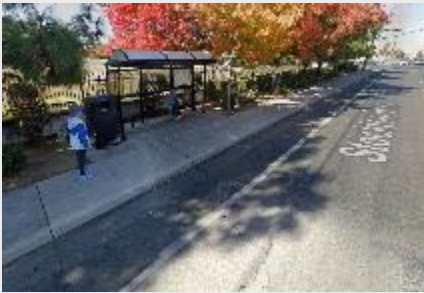
Figure A- 23 Stockton Blvd & Lemon Hill Ave

Lemon Hill Ave Northbound	Lemon Hill Ave Southbound
Stop ID	1889	1855
Daily Ridership	Boarding: 62 Alighting: 23 Total: 85	Boarding: 22 Alighting: 37 Total: 59
Cost	Tier 1: \$193,900 Tier 2: \$229,400	Tier 1: \$208,300 Tier 2: \$232,400
Key Considerations (ADA, ROW)	<ul style="list-style-type: none"> ▪ Landing Area and Curb Ramp Accessible ▪ Tier 1 and Tier 2: 0' ROW Required 	<ul style="list-style-type: none"> ▪ Landing Area and Curb Ramp Accessible ▪ Tier 1 and Tier 2: 2' ROW Required
Proposed Improvements	<p>Tier 1: Extend station area around back of sidewalk to accommodate RTIS, Braille signage, and pedestrian scale lighting. Upgrade 4 curb ramps at NE and SE corner of intersection.</p> <p>Tier 2: Create shared cycle track stop and route sidewalk behind bus stop. Add RTIS, Braille signage, and pedestrian scale lighting. Upgrade 4 curb ramps at NE and SE corner of intersection.</p>	<p>Tier 1: Widen station platform into existing landscaping area to accommodate RTIS, Braille signage, and pedestrian scale lighting. Upgrade 4 curb ramps at NW and SW corner of intersection.</p> <p>Tier 2: Create shared cycle track stop. Widen station platform to accommodate RTIS, Braille signage, and pedestrian scale lighting. Upgrade 4 curb ramps at NW and SW corner of intersection.</p>

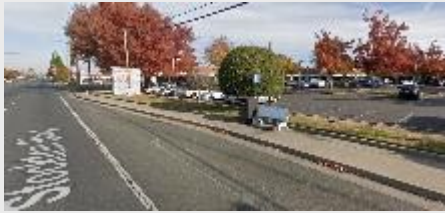
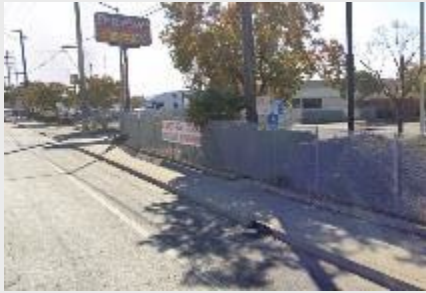
Figure A- 24 Stockton Blvd & Dias Ave

Dias Ave Northbound	Dias Ave Southbound
Stop ID	1888	1856
Daily Ridership	Boarding: 16 Alighting: 6 Total: 22	Boarding: 4 Alighting: 26 Total: 30
Cost	Tier 1: \$144,300 Tier 2: \$476,000	Tier 1: \$144,600 Tier 2: \$231,700
Key Considerations (ADA, ROW)	<ul style="list-style-type: none"> ▪ No Landing Area ▪ Tier 1 and Tier 2: 0' ROW Required 	<ul style="list-style-type: none"> ▪ No Landing Area ▪ Tier 1 and Tier 2: 4' ROW Required
Proposed Improvements	<p>Tier 1: Extend station area along back of sidewalk to accommodate accessible landing area, shelter with bench, Braille signage, and route maps.</p> <p>Tier 2: Create transit island for in-lane stop routing bike lane and sidewalk behind bus stop. Add shelter with bench, Braille signage, and route map.</p>	<p>Tier 1: Extend station area along back of sidewalk to accommodate accessible landing area, shelter with bench, Braille signage, system and route maps.</p> <p>Tier 2: Create shared cycle track stop. Add shelter with bench, Braille signage, system and route maps.</p>

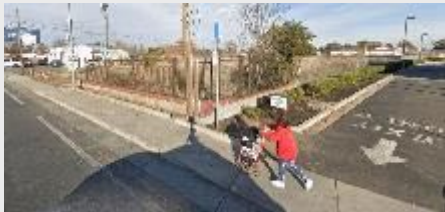
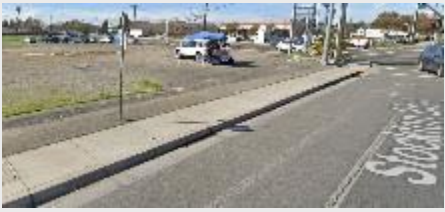
Figure A- 26 Stockton Blvd & 48th Ave

Northbound	48 th Ave Southbound
Stop ID		1858
Daily Ridership		Boarding: 6 Alighting: 10 Total: 16
Cost		Tier 1: \$15,300 Tier 2: \$183,700
Key Considerations (ADA, ROW)		<ul style="list-style-type: none"> ▪ Landing Area and Curb Ramp Accessible ▪ Tier 1 and Tier 2: 0' ROW Required
Proposed Improvements		<p>Tier 1: Relocate sign to face of curb. Add shelter with bench, Braille signage, system and route maps.</p> <p>Tier 2: Create shared cycle track stop with bench, Braille signage, and route map.</p>
Image Credit: Google Maps

- 48th Ave SB (stop ID 1858) is a midblock stop with no station pair and no amenities but it is fully ADA compliant. The bus stop flag is located at the back of the sidewalk and is not easily visible from the roadway. Due to its proximity to nearby shopping plazas and restaurants, it is recommended to add a shelter with a bench to provide a more comfortable waiting environment and increase ridership. Improvements to this location include adding a shelter with a bench, Braille signage, and system and route maps, and relocating the bus stop flag to more easily identify the bus stop.

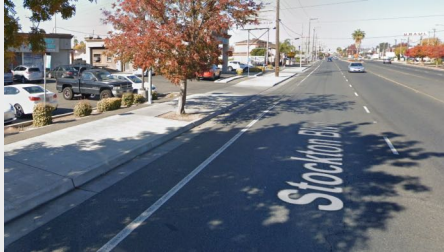
Figure A- 27 Stockton Blvd & Fowler Ave NB/ Riza Ave SB

Fowler Ave Northbound	Riza Ave Southbound
Stop ID	1885	1859
Daily Ridership	Boarding: 35 Alighting: 18 Total: 53	Boarding: 6 Alighting: 34 Total: 40
Cost	Tier 1: \$185,000 Tier 2: \$272,200	Tier 1: \$99,300 Tier 2: \$1,354,400
Key Considerations (ADA, ROW)	<ul style="list-style-type: none"> ▪ No ADA Landing Area ▪ Tier 1 and Tier 2: 6' ROW Required 	<ul style="list-style-type: none"> ▪ Landing Area and Curb Ramp Accessible ▪ Tier 1: 1' ROW Required ▪ Tier 2: 0' ROW Required
Proposed Improvements	<p>Tier 1: Extend station platform to accommodate accessible landing area. Add Shelter with Bench, Trash Receptacle, RTIS, System and route map, Braille Signage, Pedestrian Scale Lighting.</p> <p>Tier 2: Create shared cycle track stop. Extend station platform to accommodate accessible landing area. Add Shelter with Bench, Trash Receptacle, RTIS, System and route map, Braille Signage, Pedestrian Scale Lighting.</p>	<p>Tier 1: There are no occupied lots abutting this location. Maintain station location. Add Shelter with Bench, Braille signage, system and route map.</p> <p>Tier 2: If new development comes in, there is an opportunity to create transit island routing bike lane behind bus stop. Add shelter with bench, Braille signage, system and route signage. Add midblock crossing with pedestrian refuge and a pedestrian signal.</p>

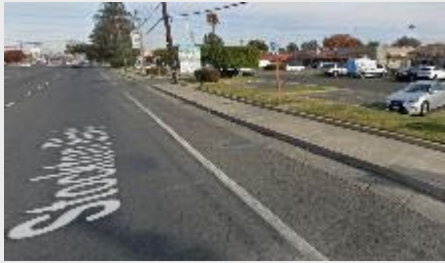
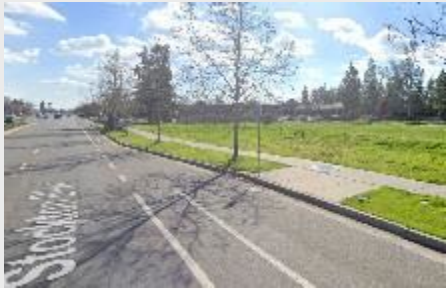
Figure A- 28 Stockton Blvd & 65th Ave

Northbound	Southbound
Stop ID	1884	1860
Daily Ridership	Boarding: 168 Alighting: 85 Total: 252	Boarding: 144 Alighting: 264 Total: 407
Cost	Tier 1: \$307,500 Tier 2: \$554,900	Tier 1: \$187,200 Tier 2: \$457,500
Key Considerations (ADA, ROW)	<ul style="list-style-type: none"> ▪ Landing Area and Curb Ramp Accessible ▪ Tier 1: 8' ROW Required ▪ Tier 2: 0' ROW Required 	<ul style="list-style-type: none"> ▪ No ADA Landing Area ▪ Tier 1 and Tier 2: 0' ROW Required
Proposed Improvements	<p>Tier 1: Extend station platform along back of sidewalk and create shared cycle track stop. Due to high daily ridership, add two shelters with benches, bench, RTIS, pedestrian scale lighting, system and route maps, and Braille signage.</p> <p>Tier 2: Create transit island routing bike lane behind bus stop. Due to high daily ridership, add two shelters with benches, bench, RTIS, pedestrian scale lighting, system and route maps and Braille signage.</p>	<p>Tier 1: Extend station platform at back of sidewalk and create shared in-lane stop. Due to high daily ridership, add two shelters with benches, bench, RTIS, pedestrian scale lighting, system and route maps, and Braille signage.</p> <p>Tier 2: Create transit island routing bike lane behind bus stop. Due to high daily ridership, add two shelters with benches, bench, RTIS, pedestrian scale lighting, system and route maps, Braille signage. Add 2 curb ramps for access to transit island.</p>

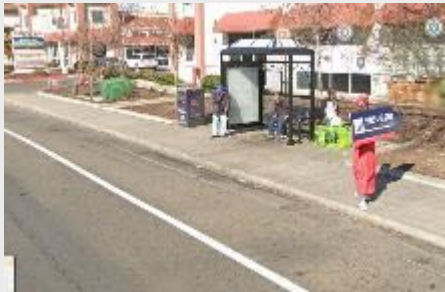
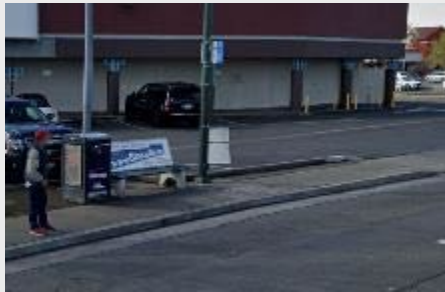
Figure A- 29 Stockton Blvd & Florin Ave NB/ Lindale Ave SB

Florin Ave Northbound	Lindale Ave Southbound
Stop ID	1861	2166
Daily Ridership	Boarding: 2 Alighting: 8 Total: 10	Boarding: 17 Alighting: 53 Total: 70
Cost	Tier 1: \$173,600 Tier 2: \$303,500	Tier 1: \$205,100 Tier 2: \$291,500
Key Considerations (ADA, ROW)	<ul style="list-style-type: none"> ▪ No ADA Landing Area ▪ Tier 1 and Tier 2: 0' ROW Required 	<ul style="list-style-type: none"> ▪ No ADA Landing Area ▪ Tier 1 and Tier 2: 4.5' ROW Required
Proposed Improvements	<p>Tier 1: Extend station area along back of sidewalk to accommodate landing area, shelter with bench, trash receptacle, Braille signage, system and route maps.</p> <p>Tier 2: Create shared in-lane cycle track stop. Extend station area along back of sidewalk to accommodate landing area, shelter with bench, trash receptacle, Braille signage, system and route maps. Upgrade 3 curb ramps on NW and SW corner of Florin Rd and Stockton Blvd intersection.</p>	<p>Tier 1: Extend station area along back of sidewalk to accommodate accessible landing area. Add shelter with bench, RTIS, trash receptacle, Braille signage, system and route map and pedestrian scale lighting.</p> <p>Tier 2: Create shared in-lane cycle track stop. Extend station area along back of sidewalk to accommodate accessible landing area. Add shelter with bench, RTIS, trash receptacle, Braille signage, system and route map and pedestrian scale lighting.</p>

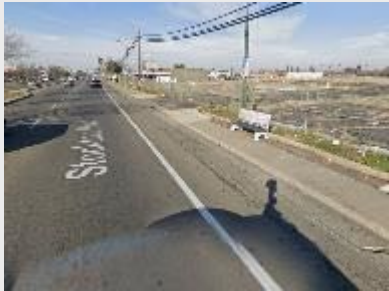
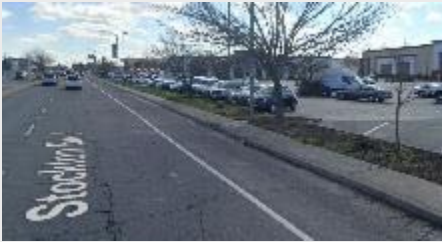
Figure A- 30 Stockton Blvd & Gerber Rd SB/ Suncountry Ln NB

Suncountry Ln Northbound	Gerber Rd Southbound
Stop ID	2376	2408
Daily Ridership	Boarding: 5 Alighting: 5 Total: 10	Boarding: 8 Alighting: 4 Total: 12
Cost	Tier 1: \$659,400 Tier 2: \$798,500	Tier 1: \$837,300 Tier 2: \$946,400
Key Considerations (ADA, ROW)	<ul style="list-style-type: none"> No Landing Area Tier 1 and Tier 2: 0' ROW Required 	<ul style="list-style-type: none"> No Landing Area Tier 1 and Tier 2: 0' ROW Required
Proposed Improvements	<p>Must: Add/widen sidewalk in missing section between Gerber Rd and NB Suncountry Ln bus stop. Upgrade 2 existing curb ramps on NE and SE corners of Gerber Rd and Stockton Blvd.</p> <p>Tier 1: Add Braille signage. No additional changes to existing bus stop</p> <p>Tier 2: Create shared cycle track stop. Add Braille signage and crossing on north leg of Massie Ct with two new curb ramps.</p>	<p>Must: Add/widen sidewalk in missing section between Gerber Rd and SB Gerber Rd bus stop. Upgrade 1 existing curb ramp on NW corner of Gerber Rd and Stockton Blvd intersection and add 1 curb ramp to SW corner of intersection.</p> <p>Tier 1: Relocate existing stop to near-side of Whispering Palms Ln. Close or relocate existing driveway to accommodate station platform with accessible landing area, bench, Braille signage, system and route maps. At Gerber Rd intersection, upgrade 3 existing curb ramps and add new curb ramp on SW corner of intersection.</p> <p>Tier 2: Create a shared cycle track stop. Relocate existing stop to near-side of Whispering Palms Ln. Close or relocate existing driveway to accommodate station platform with accessible landing area, bench, Braille signage, system and route maps. At Gerber Rd intersection, upgrade 3 existing curb ramps and add new curb ramp on SW corner of intersection.</p>

Gerber Rd SB, Suncountry Ln NB, and Massie Ct 1 SB (stop ID 2408, 2376, and 2409 respectively) are located near residential areas with some shopping plazas nearby. They all have relatively low ridership at 10, 12, and 8 daily riders, respectively. Between Gerber Rd and Suncountry Ln, roughly 400' of sidewalk is missing on the east side of Stockton Blvd and

roughly 450' of sidewalk is missing on the west side of Stockton Blvd. The Gerber Rd SB and Massie Ct 1 SB bus stops are both missing accessible landing areas and have no existing amenities. Suncountry Ln NB currently has a shelter with a bench and a tight accessible landing area.

This location received priority designation largely due to the lack of ADA accessibility in the area, from missing sections of sidewalk, curb ramps that require upgrading, and missing accessible landing areas from the two SB stops. Additionally, all improvements can be completed within the existing ROW. The anticipated cost for the Tier 1 improvements is \$1,623,800; \$659,400 for the NB stop, \$837,300 for the SB Gerber Rd stop, and \$127,100 for the SB Massie Ct 1 stop. The anticipated cost for the Tier 2 improvements is \$1,981,600; \$798,500 for the NB stop, \$946,400 for the SB Gerber Rd stop, and \$236,700 for the SB Massie Ct 1 stop.

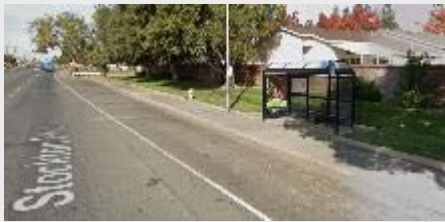
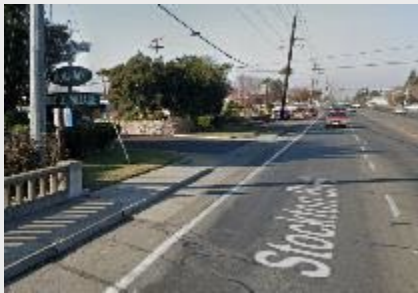
Figure A- 31 Stockton Blvd & Massie Ct 1 (SB)

Northbound	Massie Ct 1 Southbound
Stop ID		2409
Daily Ridership		Boarding: 2 Alighting: 6 Total: 8
Cost		Tier 1: \$127,100 Tier 2: \$236,700
Key Considerations (ADA, ROW)		<ul style="list-style-type: none"> ▪ No Landing Area ▪ Tier 1 and Tier 2: 0' ROW Required
Proposed Improvements		<p>Tier 1: Extend station area at back of sidewalk to accommodate accessible landing area, bench, Braille signage, system and route maps.</p> <p>Tier 2: Create a shared cycle track stop with and extend station area at back of sidewalk at bus stop to accommodate accessible landing area, bench, Braille signage, system and route maps.</p>
Image Credit: Google Maps
